**Metlakatla Indian Community Site
Non-Sampling Site Inspection
Annette Island, Alaska
TDD: 00-01-0013**

Contract: 68-W6-0008
December 2000

Region 10
START

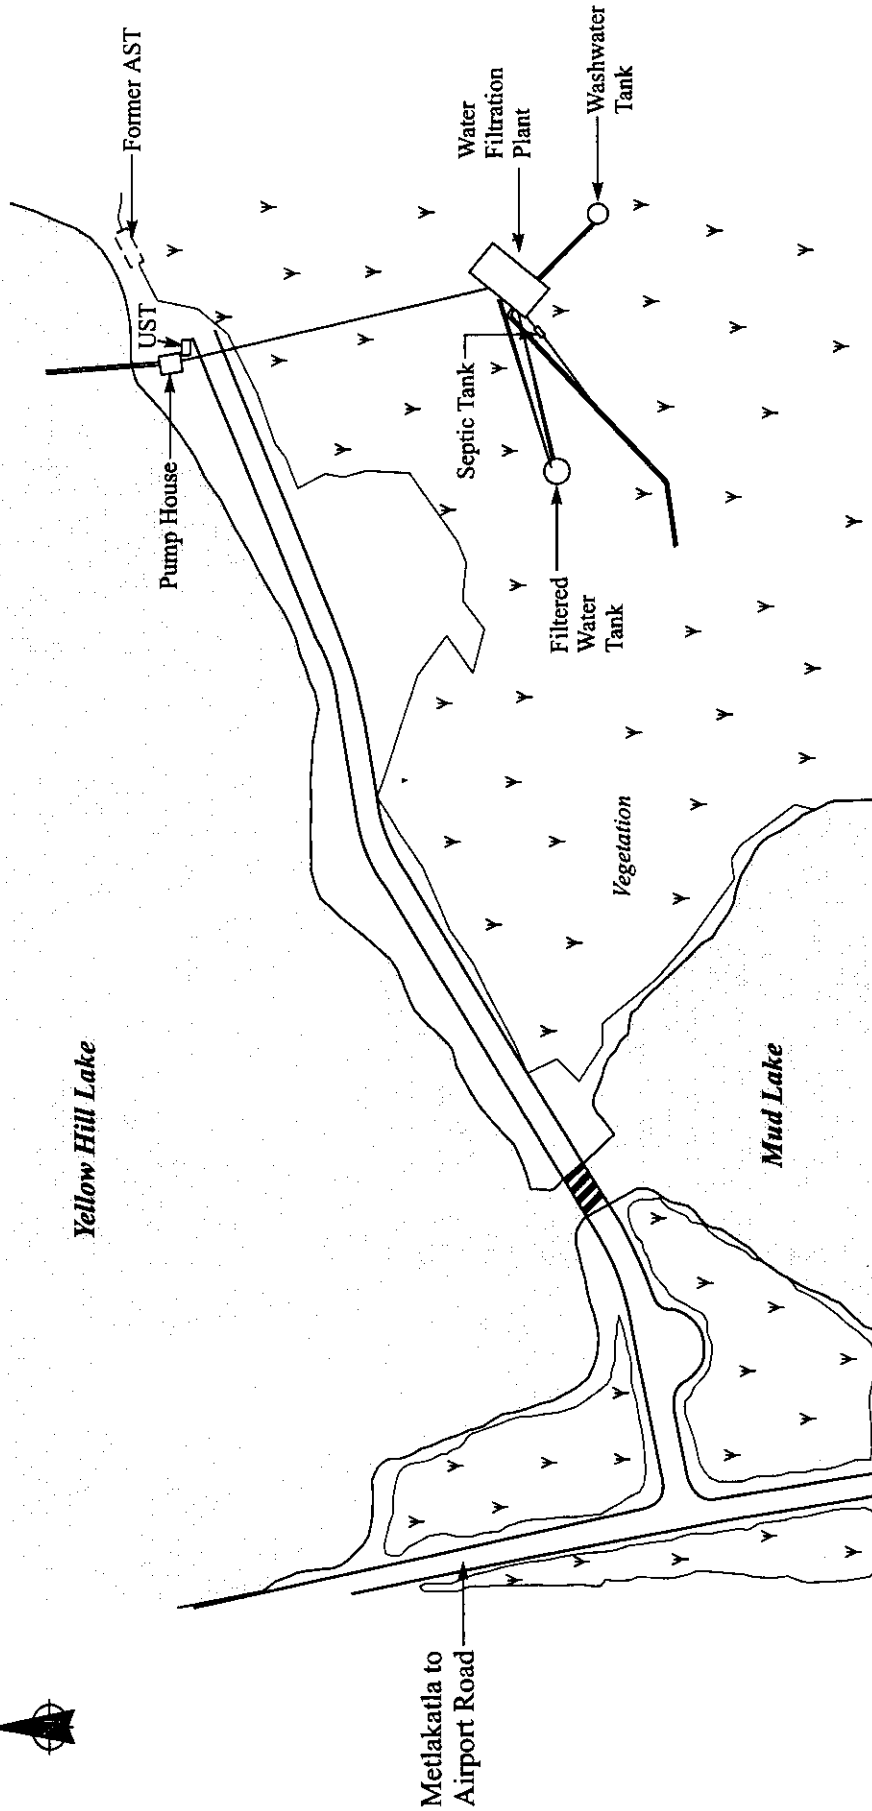
Figure 3-1
SITE 1 WATER TREATMENT PLANT

In 1941, the Department of Defense (DoD) constructed a water treatment plant adjacent to Yellow Hill Lake to supply water to the garrison areas (i.e., Sites 2 and 3) located southwest of Yellow Hill. The site consisted of a pump house, a water filtration plant, an AST and UST located near the pump house, a wash water tank, a filtered water tank, and a metal hut suspected to be a powerhouse used to operate the facility (Figure 3-1). Remains at the facility include the water intake pump house, the filtration plant, a metal hut, and a large concrete foundation that formerly housed the AST. Environmental concerns at the site include possible petroleum, oil, and lubricants (POL) contamination as a result of an on-site fuel tank next to a generator building. Mercury may be present as a result of switches used at the facility. Polychlorinated biphenyls (PCBs) are a possible contaminant of concern because of the presence of a generator building at the facility. (REI 1998a; MOU 1999)

Mercury and POL are documented to exist in on-site media. PCBs remain a contaminant of concern at the site based on limited investigation of PCB presence and suspected power house operation at the site. Approximately \$250,000 of restoration activities are proposed through fiscal year 2001; proposed actions include surface soil sampling, possible soil treatment, Yellow Hill Lake sediment cleanup, removal of solid debris, and possible access road and bridge repair. The lead agency in restoration activities is the FUDS Program associated with the USAED, Alaska. (MOU 1999)

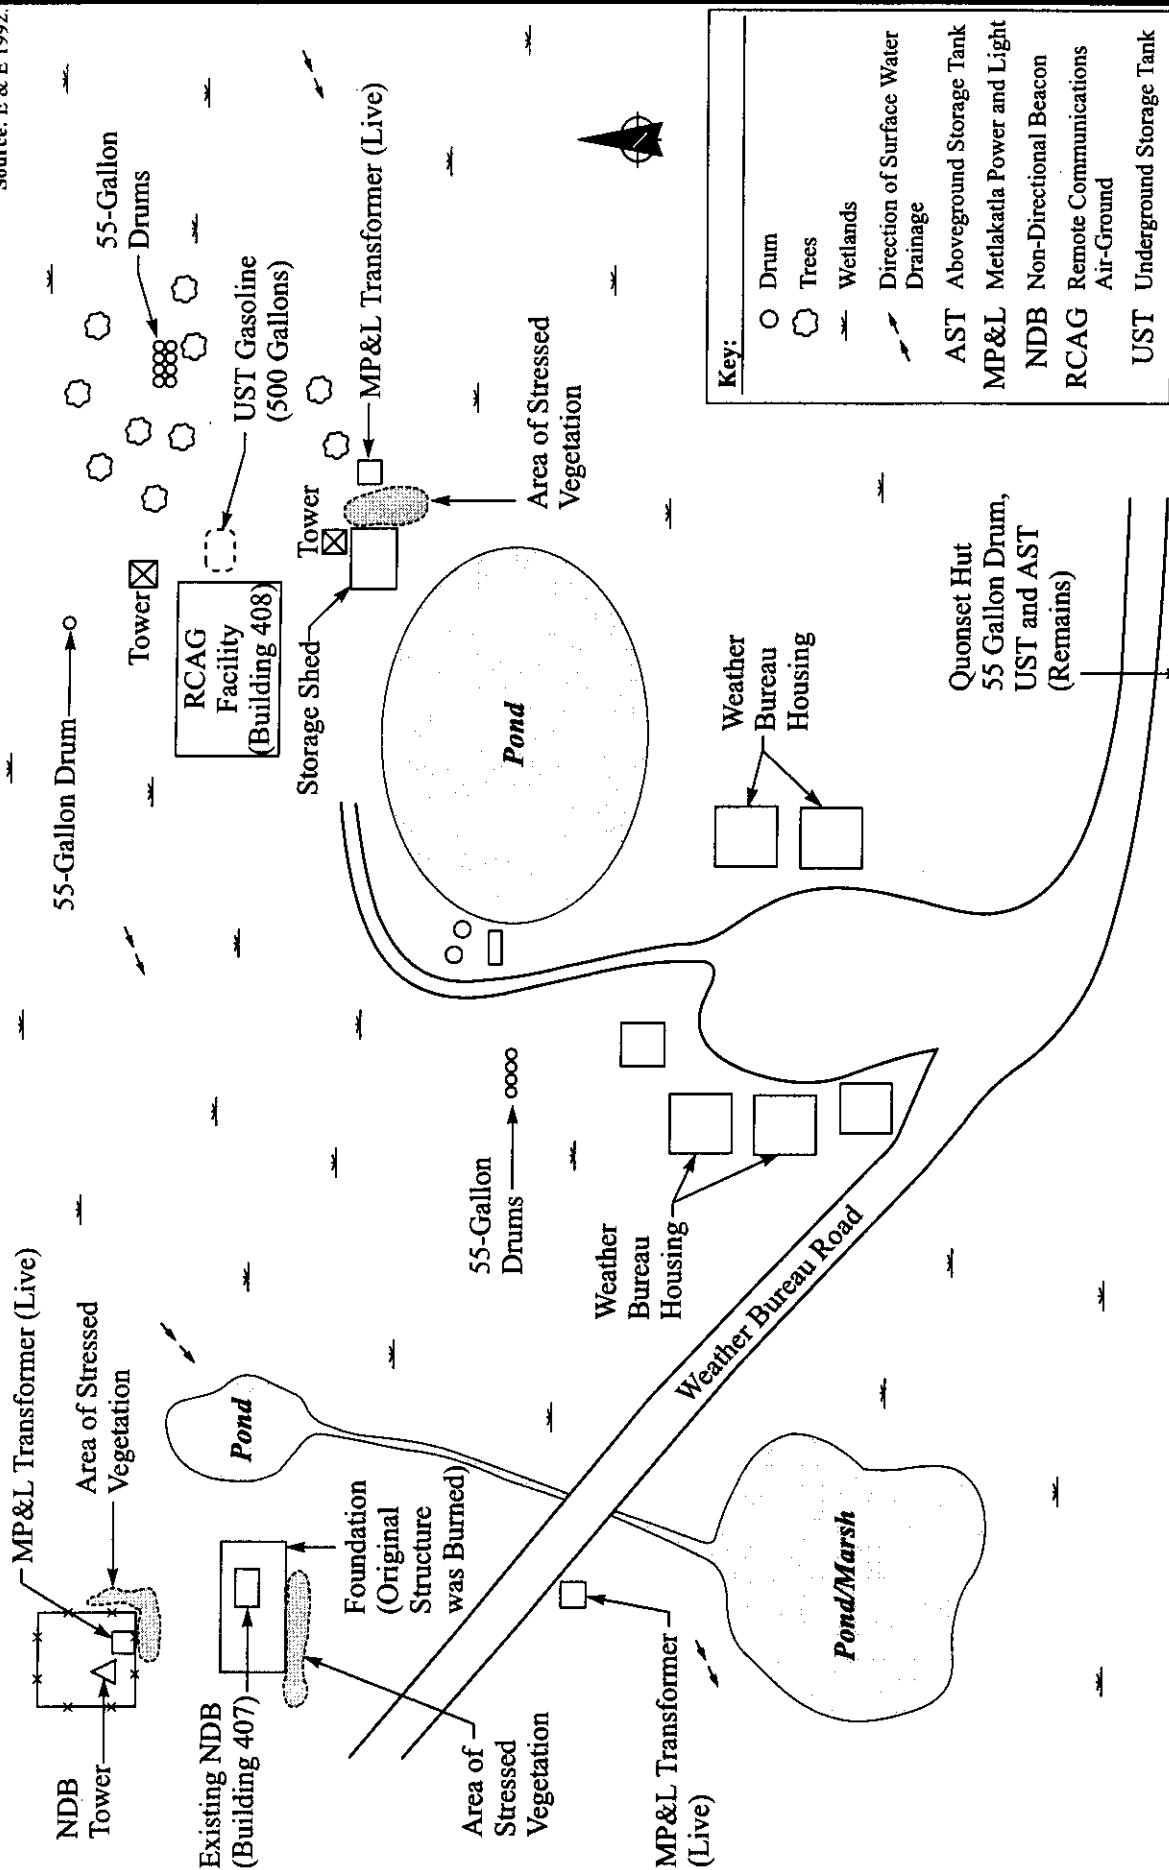
Figure 3-10

The Non-Directional Beacon (NDB)/H-Marker Facility is located on 10 acres at the end of Weather Bureau Road. The former NDB building reportedly burned down completely in the early 1980s. The facility consists of a fiberglass building that houses active electronic equipment and a fenced antenna tower with a live transformer. Four other antenna towers are on the ground at the site (Figure 3-10). Lead concentration in surface soil was identified as a concern during an FAA Environmental Compliance Investigation. The presence of lead does not appear to be related to a possible leaded fuel source; a likely source is lead-based paint on the antenna towers and original NDB building. Electrical equipment at the facility has not been sampled; hence, PCBs are a potential contaminant of concern. ACM was identified in building materials at the NDB facility. (E & E 1992)

The FAA conducted an expanded site investigation (ESI) at the NDB/H-Marker Facility to further delineate the extent of lead contamination, identify other contaminants in source areas (i.e., soil around the former NDB building foundation), and investigate the migration of contaminants to environmental targets near the facility. Source and target samples were analyzed for TAL metals, dioxins/furans, pesticides/PCBs, VOCs, and base/neutral and acid extractable organic compounds (BNA). Analytical data indicates that approximately 150 cubic yards of lead-contaminated soil are present at the site. In addition to lead, numerous other metals are present in source area soil samples at a concentration greater than three times the background concentration, including arsenic, barium, chromium, cobalt, copper, magnesium, nickel, selenium, and zinc. Also, multiple dioxin/furan isomers were detected in source soil samples; however, total dioxins/furans never exceeded one part per billion toxicity equivalency factor in any sample. Various BNA commonly associated with petroleum products were also detected in source soil samples at estimated quantities. Stressed vegetation was observed along the east and south sides of the NDB building foundation and the antenna chain-link fence. Target sediment samples were collected from a wetland drainage south of the NDB building foundation and along this drainage to Smuggler Cove. Metals, dioxins/furans, and BNA were detected in wetland sediment samples up to Smuggler Cove, indicating possible contaminant migration from the site to Smuggler Cove. (E & E 1995a)

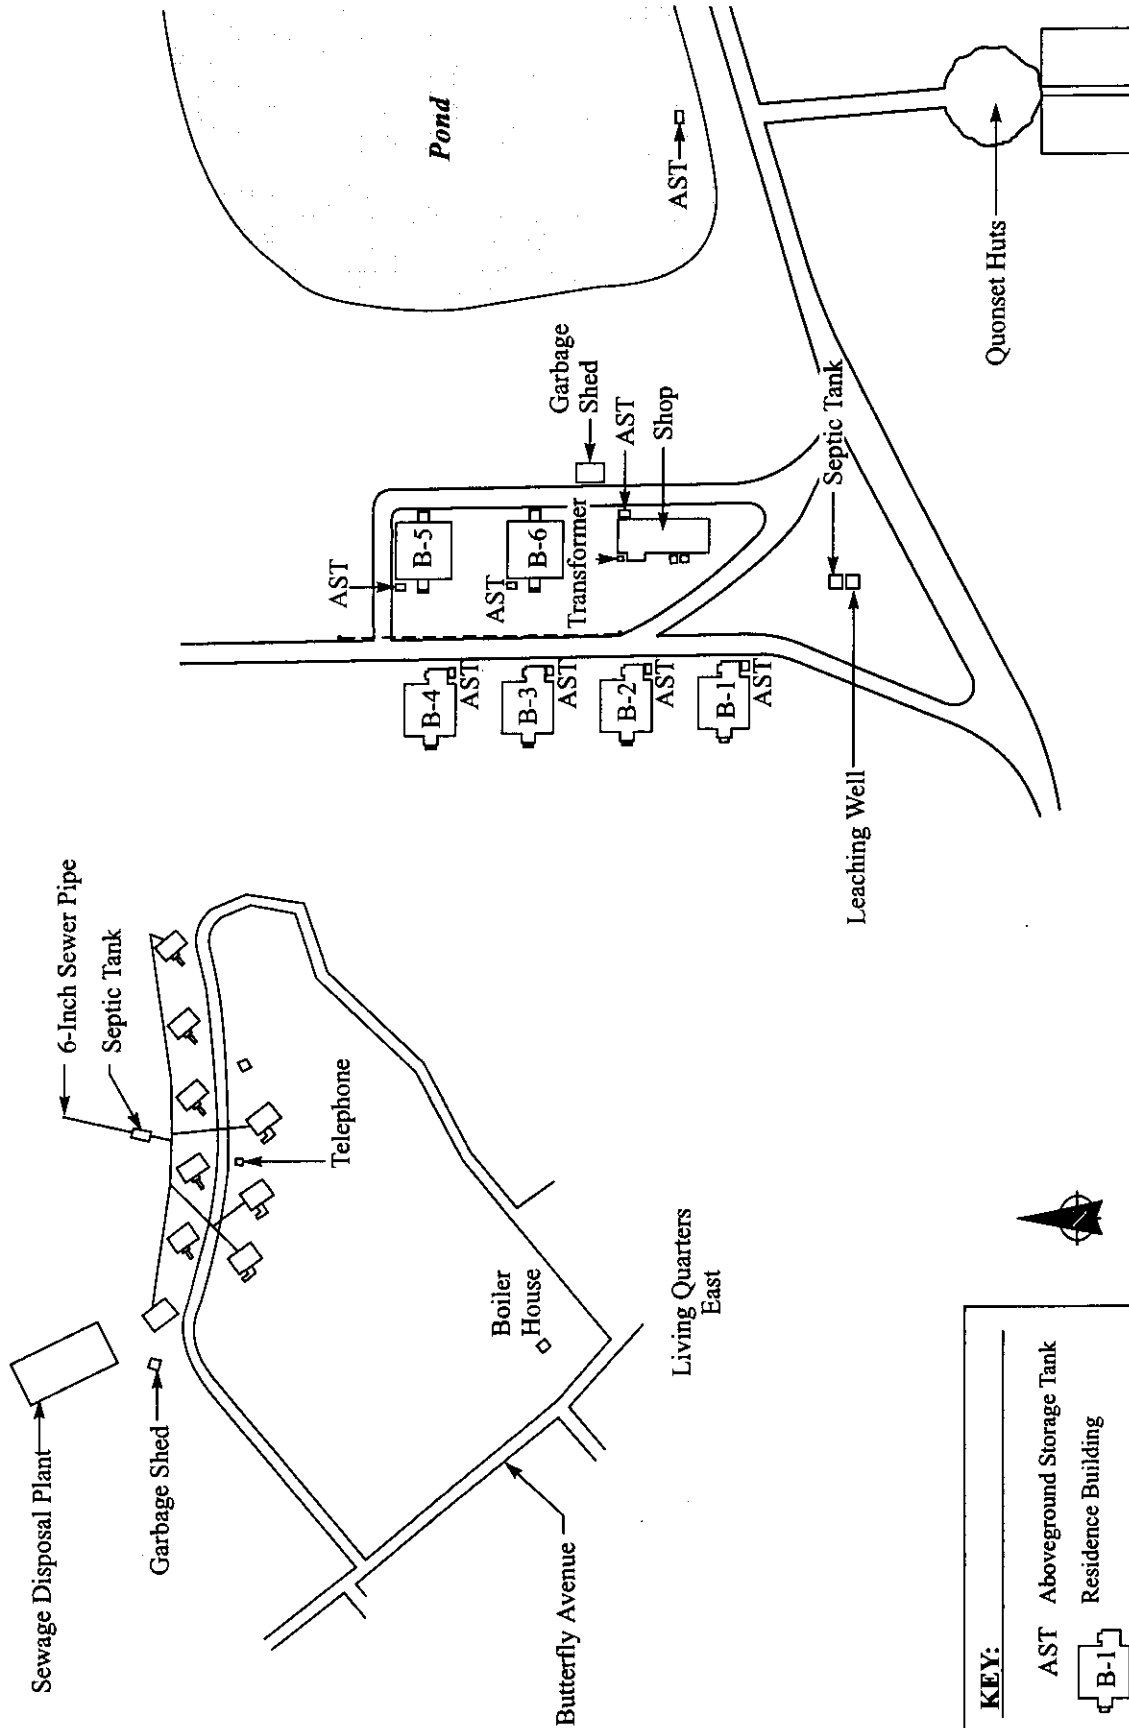
Figure 3-11
SITE 20 WEATHER BUREAU HOUSING

Built in the late 1940s, the Weather Bureau Housing is an active facility consisting of seven wooden buildings, 6 residence buildings and one maintenance building (Figure 3-10). An AST is located adjacent to each building, with soil potentially contaminated with POL under each AST (Figure 3-11). However, no obvious stains or odors have been observed around the tanks. Several metal quonset huts are located southeast of the housing area. An abandoned AST is located approximately 100 feet east of the housing complex in a pond on the north side of the road (Figure 3-11). A surface soil sample was collected underneath the AST at Building 3 in the central portion of the housing complex. Contaminants detected in the sample include GRO (68 mg/kg), DRO (9,700 mg/kg), lead (557 mg/kg), and xylene (180 µg/kg). (REI 1998b)
